WOOD DESTROYING PESTS AND ORGANISMS INSPECTION REPORT

BUILDING NO.	STREET	CITY	ZIP	DATE OF INSPECTION	NUMBER OF PAGES
6652	Waverly Road	Martinez	94553	8/27/08	7

HARVEY CONSTRUCTION, INC. 522 JERSEY ST. VALLEJO, CA. 94590 (707)648-1484	A licensed pest control operator is an expert in his/her field. Any questions relative to this report should be referred to him/her.
--	--

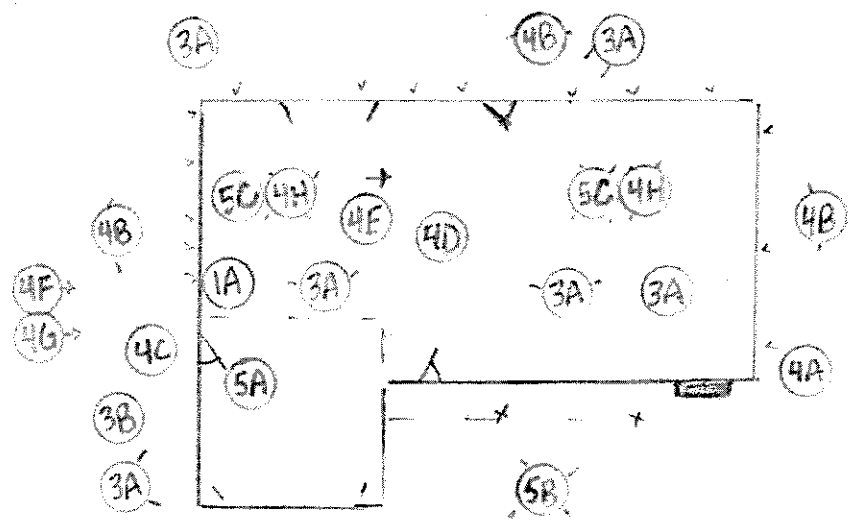
Evidence of subterranean termite damage found in substructure framing.

Fungus damage found in end of barge rafters.

Fungus infestation found to roof eave sheathing in area indicated. This condition was caused from past or present roof leaks.

Remove exterior stucco. Perform further inspection on exposed framing. Repair framing as needed. Restucco and prime paint. Trench or rod soil and/or drill through concrete where needed adjacent to exterior of foundation and treat soil with Premise for termite control. Fill holes in concrete. Treat adjacent to subarea foundation in this area.

Cut barge rafters to remove damage. Install new material to match existing as near as practical. Prime paint new wood.

Repair eave areas as necessary. Prime paint new wood.
